Product Support Bulletin

To:	HydraMaster Distributors		
Document #:	PSB-44275	Effective Date:	12/01/10
Title:	Titan 875 Check Engine Light

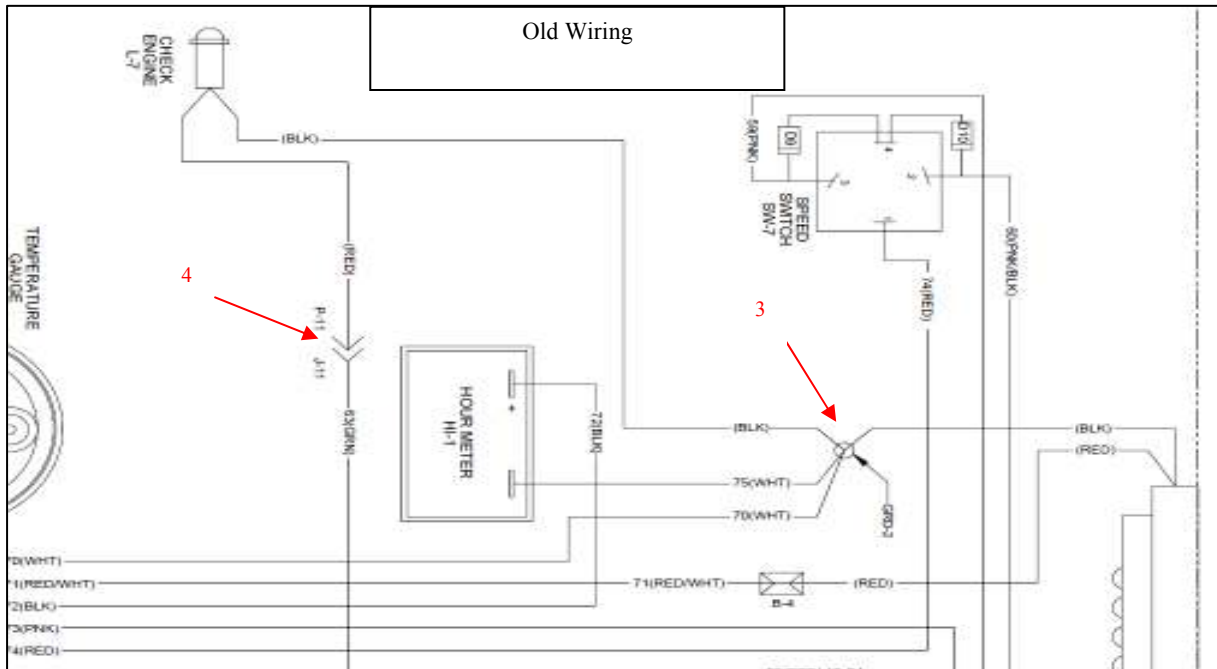
We have received reports of the check engine light not operating properly on the Titan 875 due to reversed wires. This will not affect the performance of the 875 but in some cases will trigger a code when viewed through the engine diagnostic software.

Note: Please verify that your machine requires this modification prior to proceeding. Locate the black wire reference in item #3 below (and the “Old Wiring” image on the next page). If this wire goes to the ground lug GRD-2 you will need to proceed with this modification. If it does not your machine is properly wired already.

1. Disconnect the battery.
2. Remove the left side machine cover.
3. Remove the black wire from the ground stud just above the hour meter.
4. Remove the butt connector that attaches the red wire to the green wire.
5. Attach the black wire from the check engine light to the green wire with a butt connector.
6. The red wire will need to be attached inline with the red/wht wire that feeds power to the upper dash blue LED strip.
 - a. Cut out the butt connector that attaches the red/wht wire to the red wire for the blue LED strip.
 - b. Using a new butt connector crimp the red/wht wire to one side.
 - c. Crimp the red wire from the blue LED strip along with the red wire from the check engine light to the other side of the butt connector.
7. Connect the battery.
8. Test machine to verify the light is not active.

Note: In case the light is active the, engine will need to be connected to the diagnostic software to clear the code.

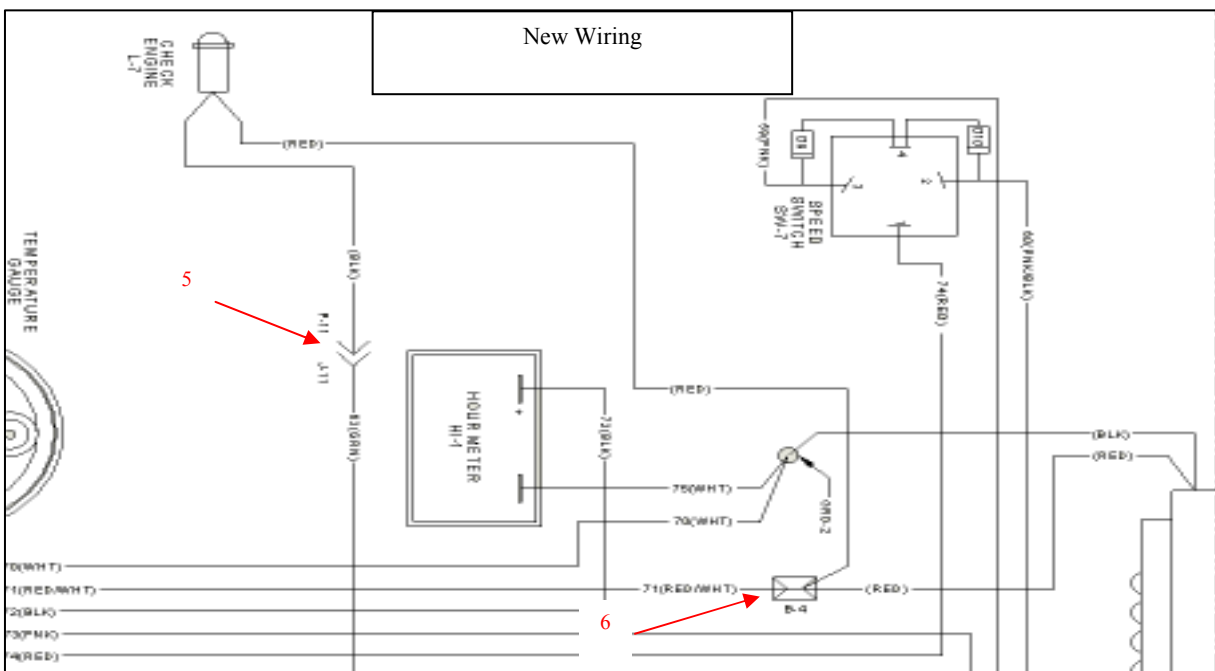
To correct this, the wires need to be connected according to the follow procedure (reference the old wiring and new wiring diagrams on the following pages). Please contact HydraMaster Technical Support if you have any questions.
