Product Support Bulletin

To:	All HydraMaster Distributors		
Document #:	PSB-45088	Effective Date:	4/12/12
Title:	Fuel Hose Clamps on Titan 575

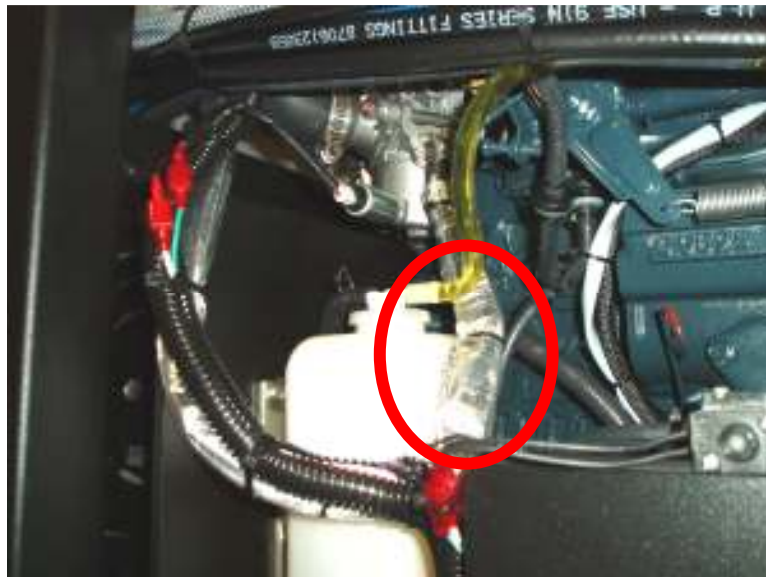
When adapting the Kubota engine for use in the Titan 575 it was decided to leave the fuel line on the machine the same size as the original design. However the carburetor on the Kubota engine requires a smaller fuel line. To accommodate this, a fuel line reducer was installed a few inches down from the carburetor that connects the 5/16 and 1/4 fuel lines.

In a few cases, we have found that the fuel hoses at this reducer did not get clamps installed on them. This is a very low pressure application and in most cases this will not pose an immediate problem. However, as a precaution, the needed clamps have been included with this notification - along with instructions on the next page to perform the inspection and repair. The repair should take approximately 0.5 hours to perform. HydraMaster will reimburse distributors following standard warranty procedures.

PSB-45088 instructions:

1. Verify the key switch is off and the fuel pump is off.
2. Using a 5/16" nut driver, loosen the clamp and remove the hose at the carburetor.
3. Drain any excess fuel from the hose.
4. Cut the foil insulation approximately 7" down from the end of the hose. Use side cutters to cut through the folded-over edge, length-wise, and continue to carefully trim around the hose.
5. Install hose clamps on each end of the hose. The clamps are HydraMaster P/N 000-033-003 Size #4 Mini Hose Clamps.
6. Run and test machine to verify there are no leaks in the hose.
7. Install the cut piece of insulation back onto the hose, fold over the excess and secure with tie wraps.
